INVENTORY OF MONUMENTS AT PAGAN

Volume One
Monuments 1-255

PIERRE PICHARD

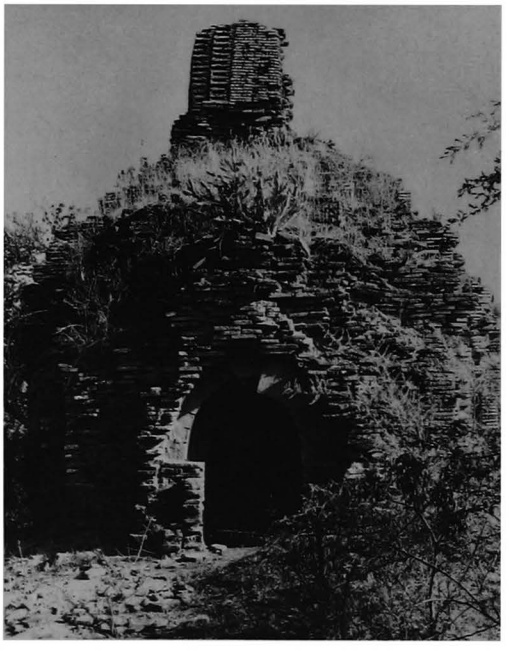
1087 b - North face

5 present condition
- no maintenance.
- half-ruined.
- upper parts badly damaged.

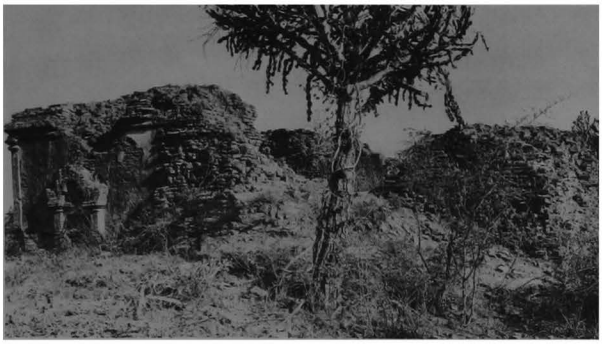
1088 b - From north-west

5 present condition
- ruined.
- vaults and upper parts collapsed.
- ground floor buried under debris.

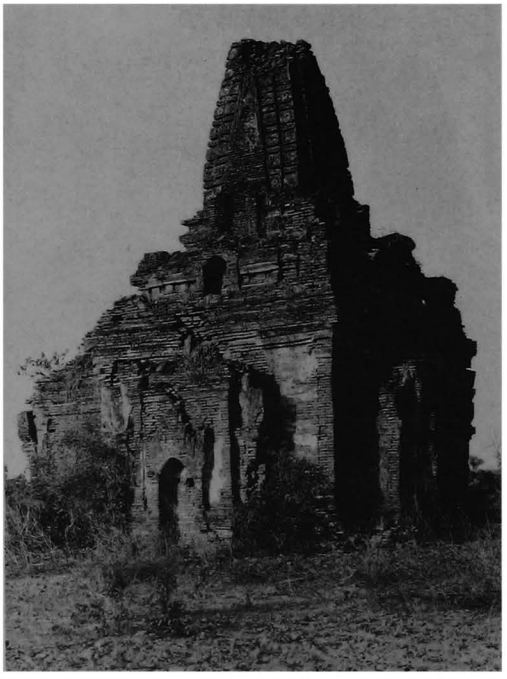
5 present condition
- no maintenance.
- north porch and terraces badly damaged.

1089 b - From south-west

1089 c - North face

1089 d - Shrine, south wall and image, from north

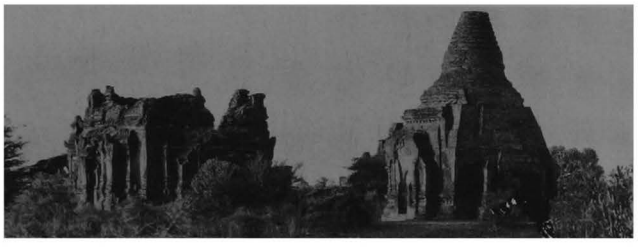
1091 b - From south-west, together with 1094

5 present condition
- regularly maintained.
- repaired 1965-66.
- brick grille built by Arch. Dept.

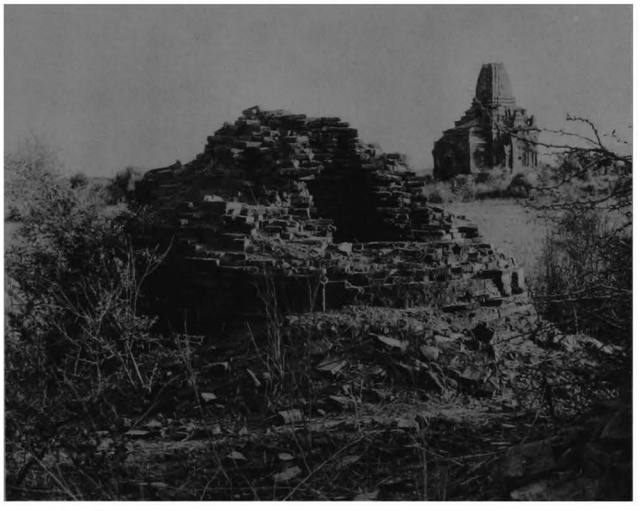
1093 b - From north, together with 1092

5 present condition
- half-ruined.
- only base remains.

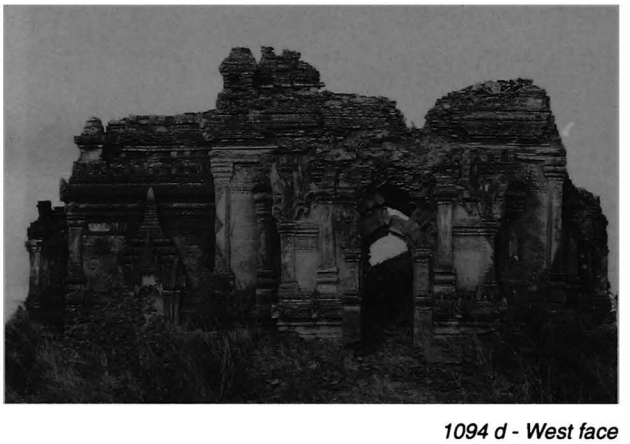
1094 d - West face

5 present condition
- half-ruined.
- vault over shrine and upper parts collapsed.
- ground floor partly buried under debris.

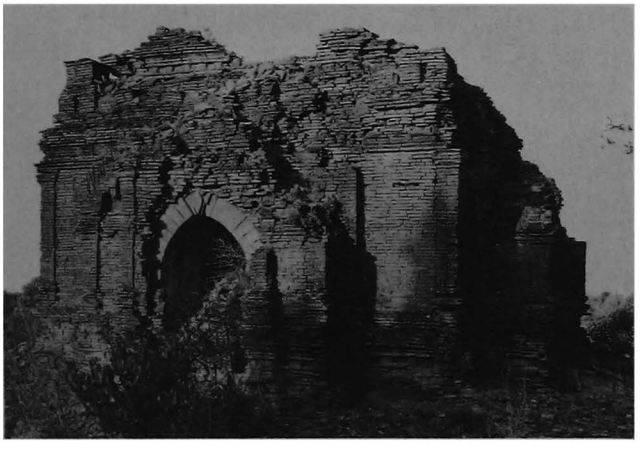
1095 b - West face, from south-west

5 present condition
- ruined.
- vaults and upper parts collapsed.
- ground floor buried under debris.

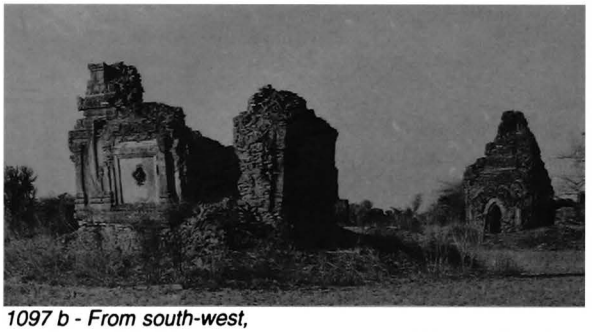
1097 b - From south-west, together with 1098

5 present condition
- ruined.
- vaults and upper parts collapsed.
- ground floor buried under debris.

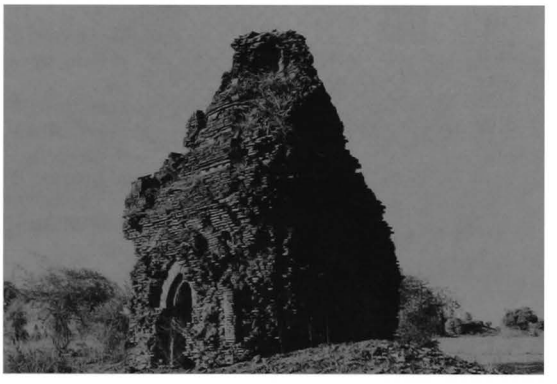
1098 b - From south-west

5 present condition
- half-ruined.
- base and wall-facing disintegrated.
- porches collapsed.
- upper parts badly damaged.

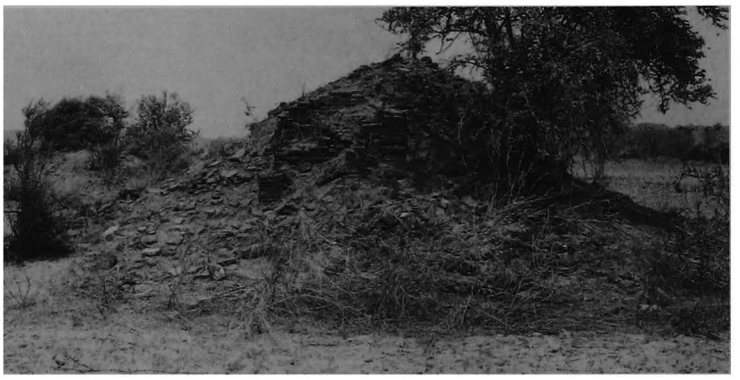
1099 c - From south

5 present condition
- ruined.
- ground floor buried under debris.

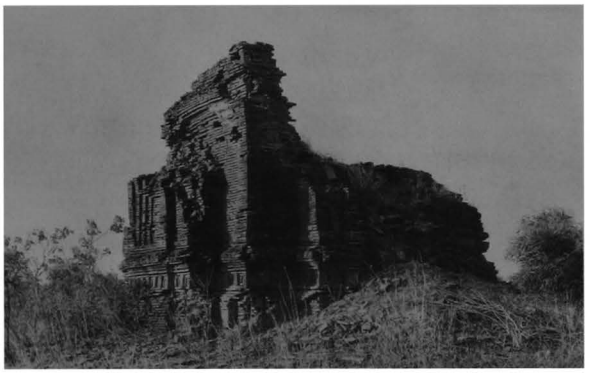
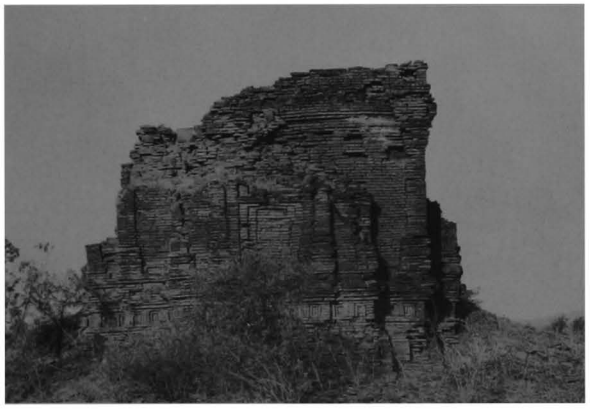
5 present condition
- ruined.
- vaults and upper parts collapsed.
- ground floor buried under debris.

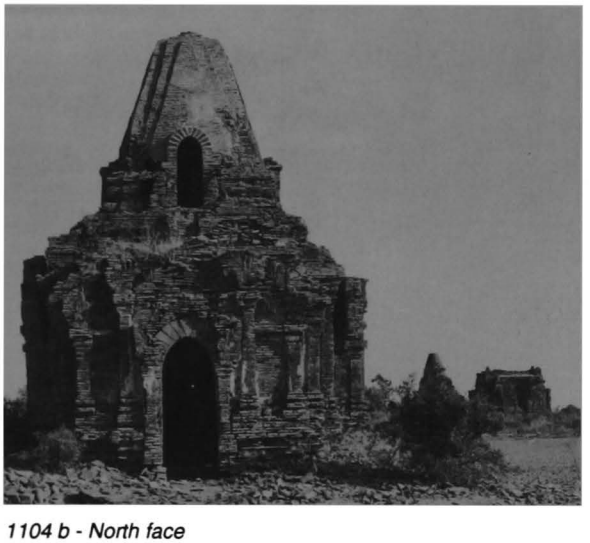
1104 b - North face

5 present condition
- no maintenance.
- north porch collapsed.
- upper parts badly damaged.

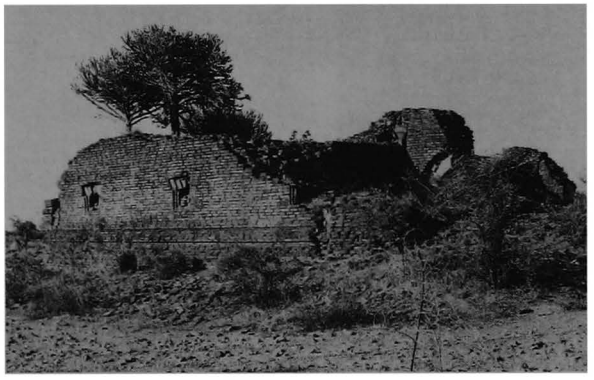
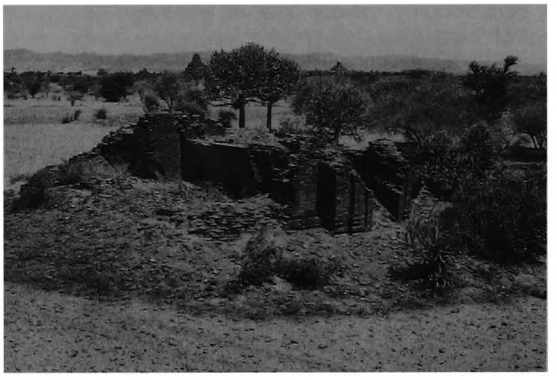
5 present condition
- ruined.
- no more trace of vaults.
- ground floor buried under debris.

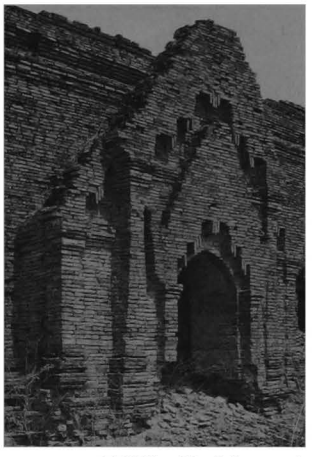
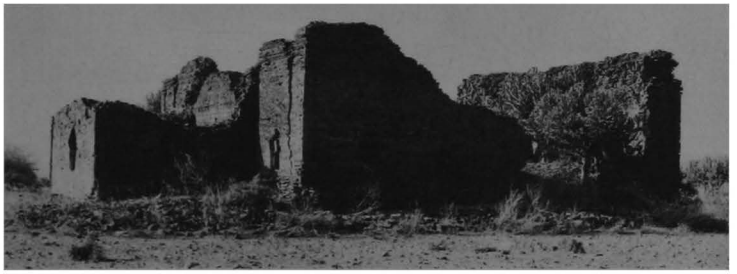
5 present condition
- ruined.
- vault collapsed.
- ground floor buried under debris.

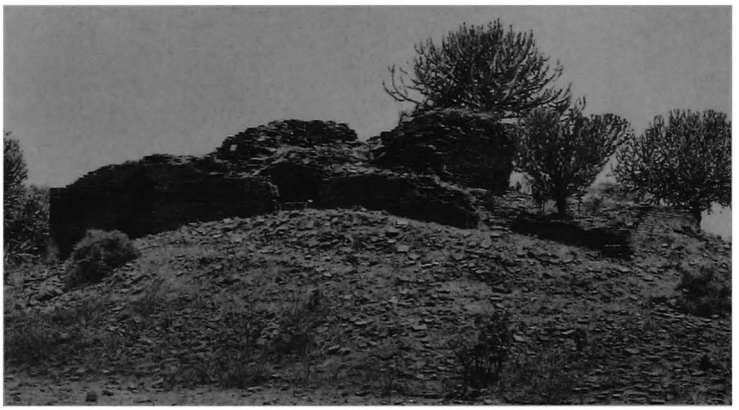
1108 d - South face, from south-east

5 present condition
- ruined.
- vault collapsed.
- ground floor buried under debris.

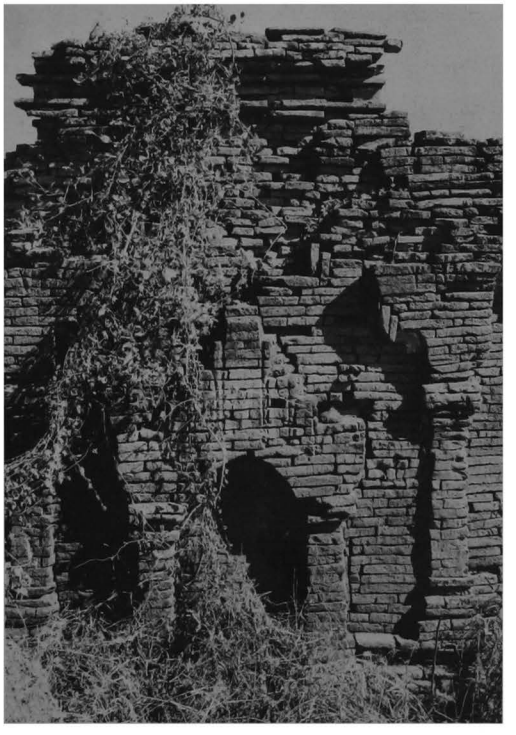
1109 d - West face

5 present condition
- ruined.
- vaults and upper parts collapsed.
- ground floor buried under debris.

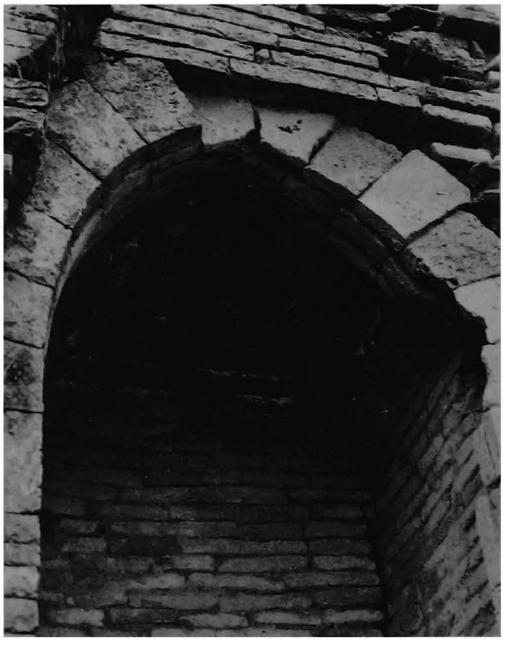
1110 d - East face, detail of axial niche

5 present condition
- ruined.
- vault collapsed.
- ground floor buried under debris.

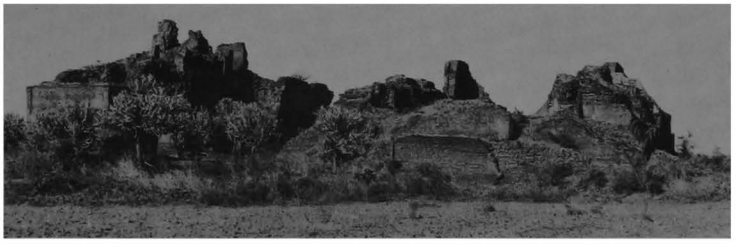
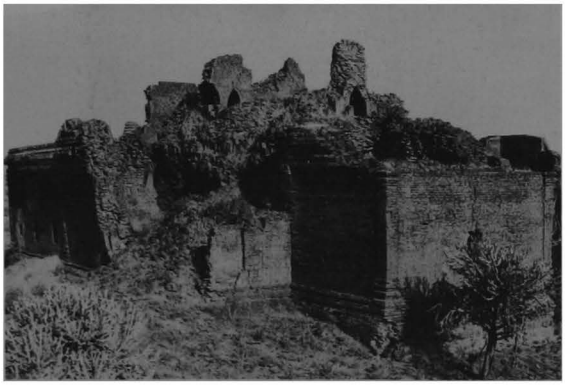
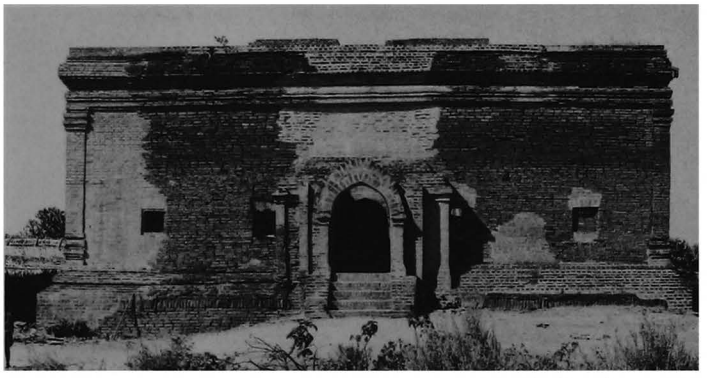
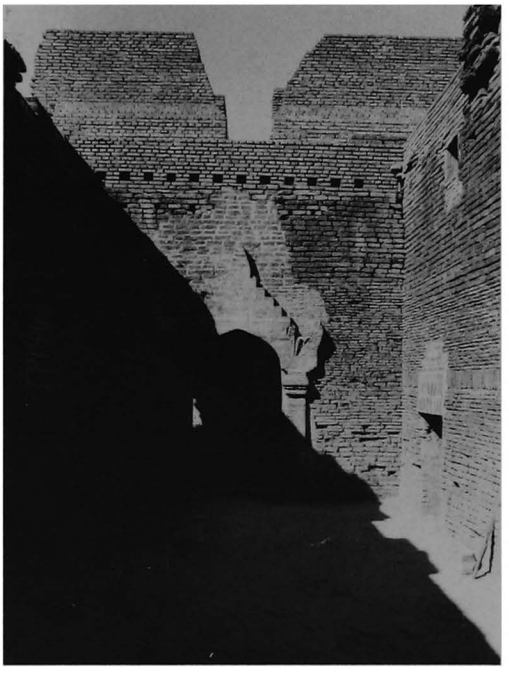
5 present condition
- half-ruined.
- upper storey collapsed.
- repaired 1966-67, 1970-73 and (P.W.) 1992.

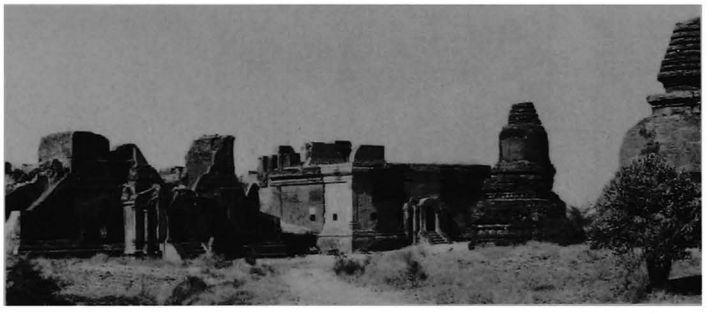
1112 b - From south-east, 1994, together with 1111, 1114 and 1113

5 present condition
- half-ruined.
- upper storey collapsed.
- ground floor partly buried under debris.
- repaired 1966-67.

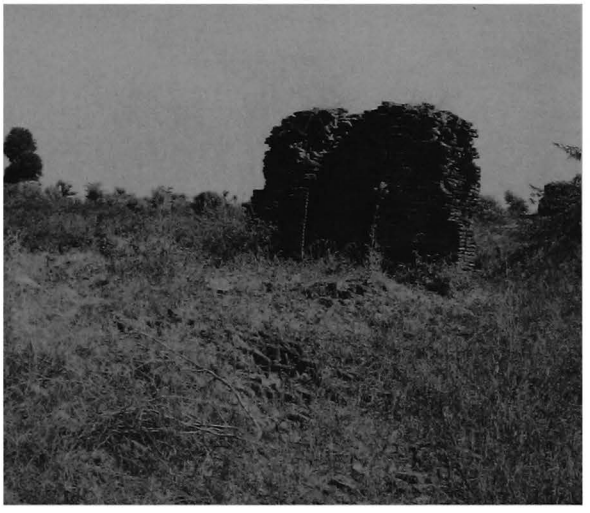
5 present condition
- remaining part of east wall collapsed 1987.
- unexcavated mound, present height: 1.00 m.

1115 b - From south-west, remaining part of east wall, 1986

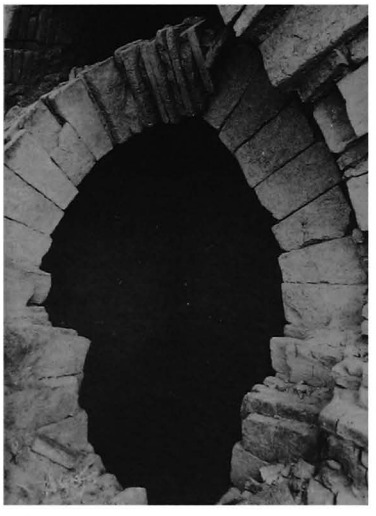
5 present condition
- half-ruined.
- terraces disintegrated.
- upper parts badly damaged.
- repaired (Arch. Dept.) 1992.

1117 d - South face, 1986

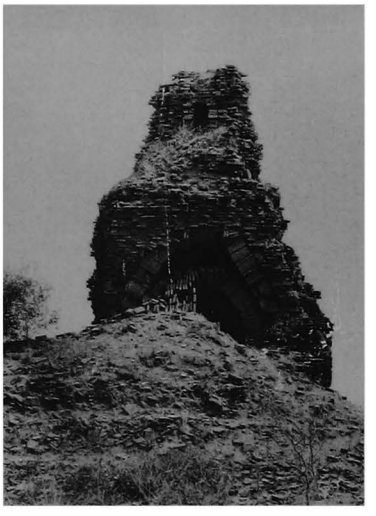
1117 e - South face, 1992

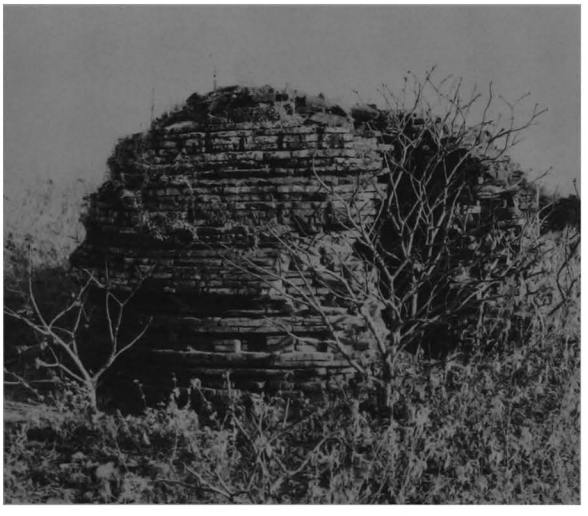
5 present condition
- ruined.
- base buried under debris.
- upper parts nearly destroyed.

1118 b - From north-west

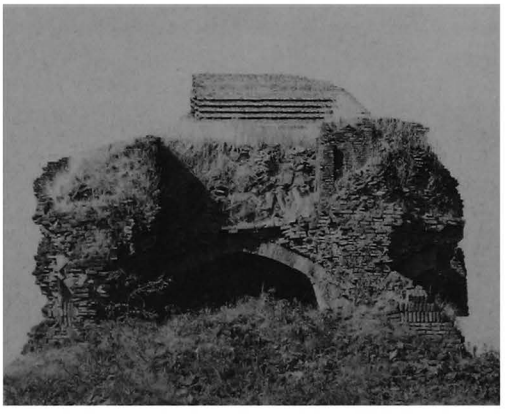
5 present condition
- half-ruined.
- walls and vault partly collapsed.
- ground floor buried under debris.
- repaired (Arch. Dept.) 1971 and 1993.
- upper part damaged by the 1975 earthquake.

1123 b - East face

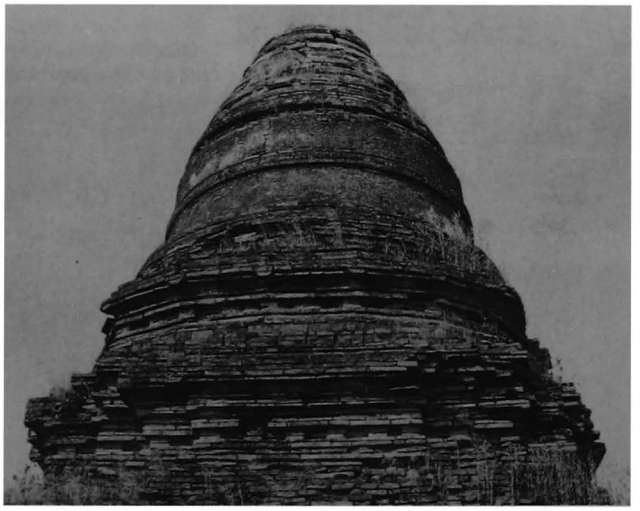
5 present condition
- no maintenance.
- base disintegrated.
- upper parts damaged.

1124 b - Upper parts, east face

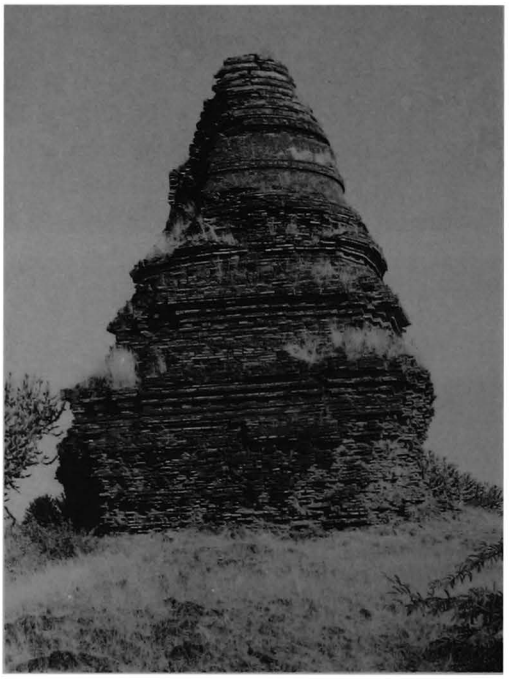
1124 c - From south-west

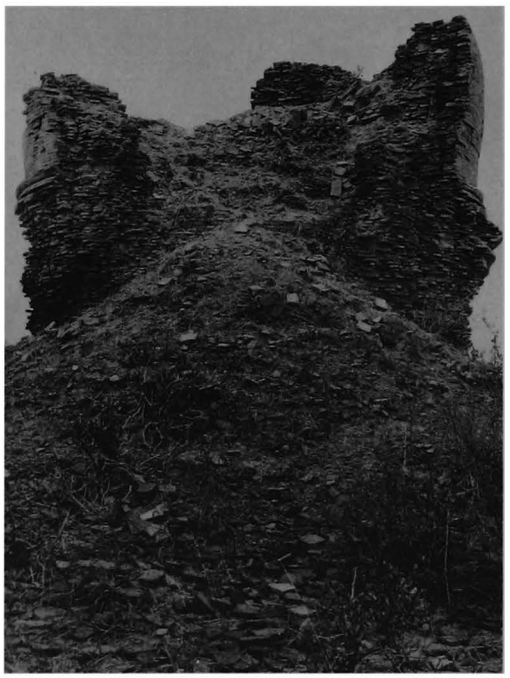
5 present condition
- ruined.
- base and terraces disintegrated.

1126 c - From south-east

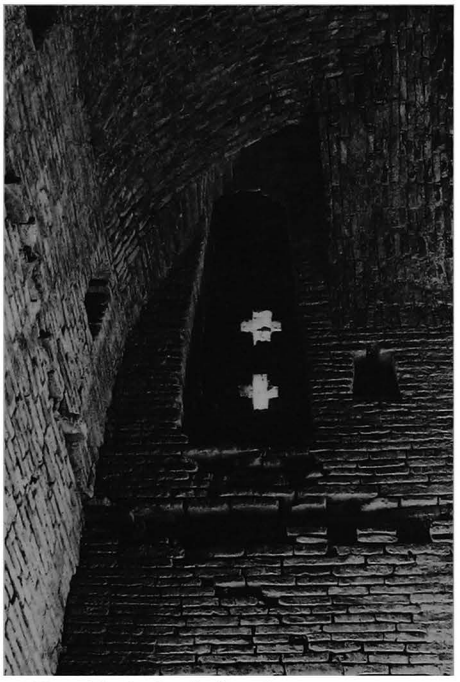
1129 e - Vault, detail of north-east corner and access to staircase to roof, from west

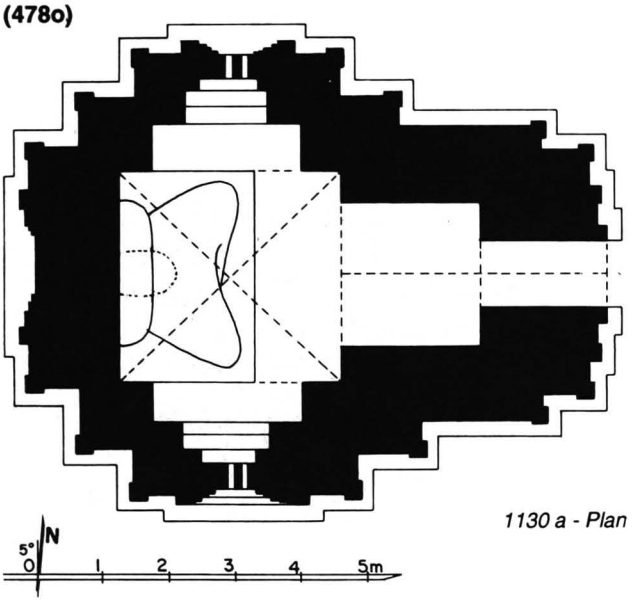
1130 a - Plan

5 present condition
- base disintegrated.
- upper parts badly damaged, repaired (Arch.Dept.) 1988.

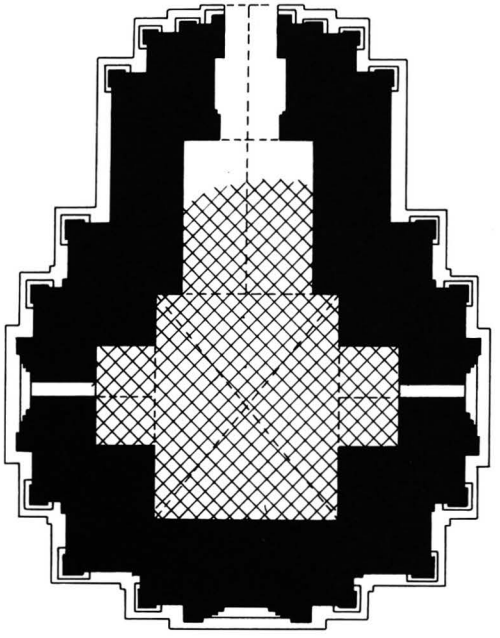
1131 a - Plan

5 present condition
- half-ruined.
- shrine vault collapsed.
- upper parts nearly destroyed.
- ground floor buried under debris.

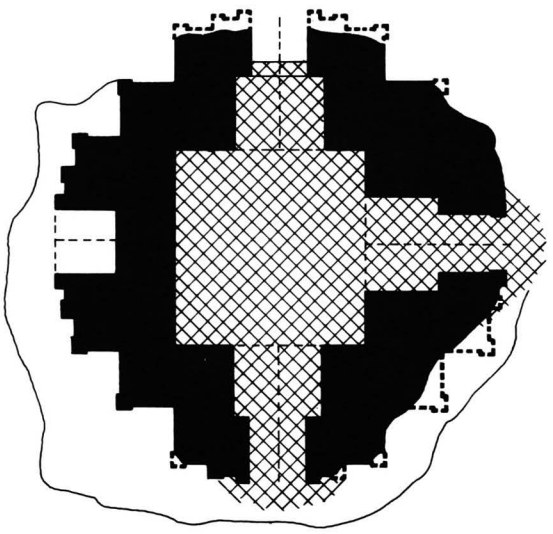
1132 a1 - Upper-storey plan

5 present condition
- ruined.
- base disintegrated.
- vaults and upper parts collapsed.
- upper floor buried under debris.

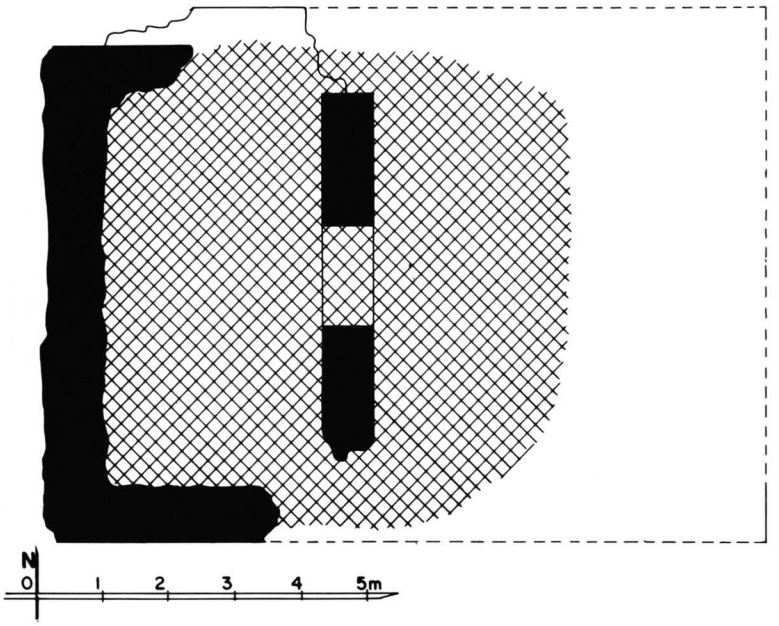
1134 a - Plan

5 present condition
- ruined.
- vaults and roof collapsed.
- ground floor buried under debris.

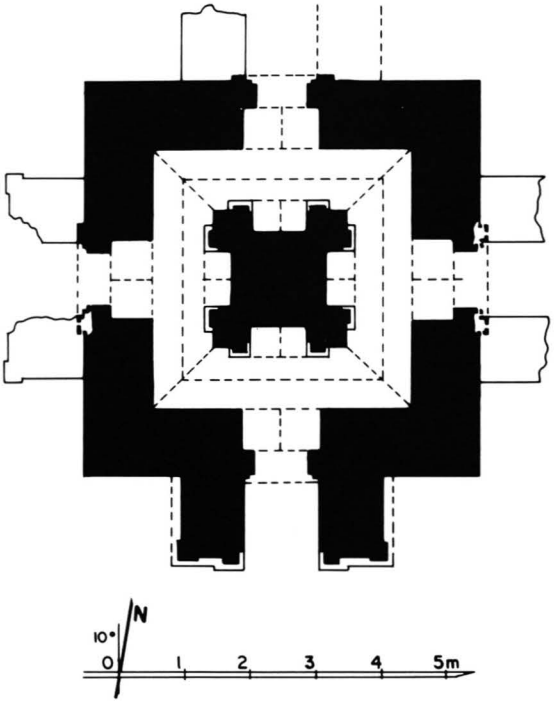
1135 a - Plan

5 present condition
- no maintenance.
- porches collapsed.
- terraces disintegrated.
- upper parts nearly destroyed.

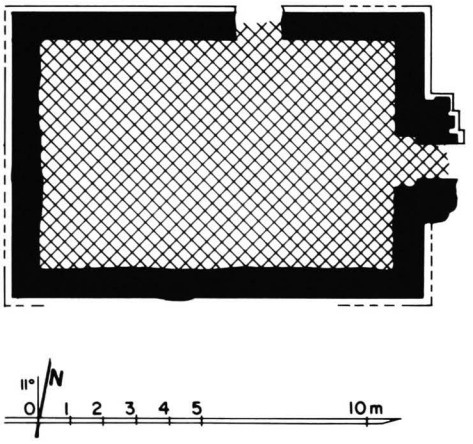
1136 a - Plan

5 present condition
- ruined.
- only base of walls remains.
- ground floor buried under debris.

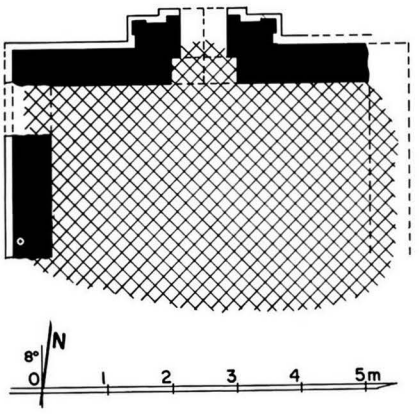
1137 a - Plan

5 present condition
- ruined.
- vaults and upper parts collapsed.
- ground floor buried under debris.

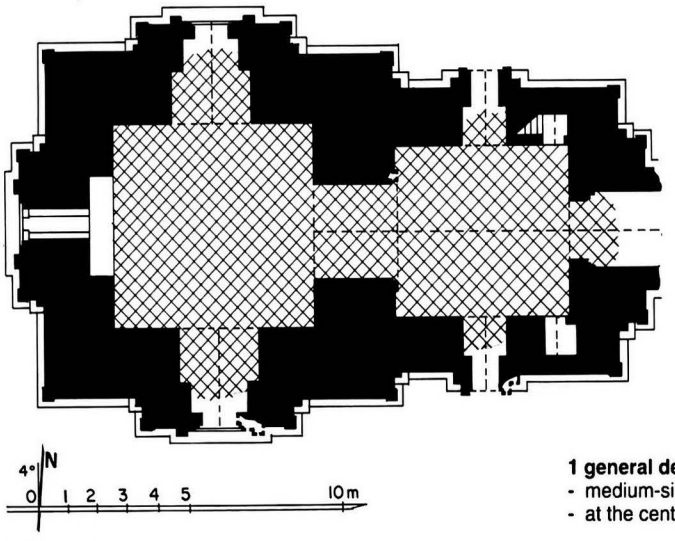
1138 a - Plan

5 present condition
- half-ruined.
- base disintegrating.
- vaults and upper parts collapsed.
- ground floor buried under debris.

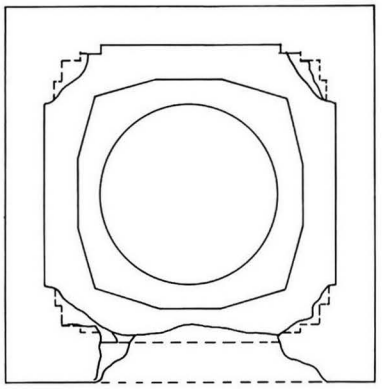
1139 a - Plan

5 present condition
- no maintenance.
- base and terraces disintegrated.
- upper parts nearly destroyed.

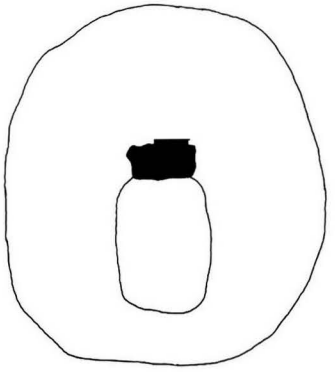
1140 a - Plan

5 present condition
- ruined.
- base disintegrated.
- height: approx. 2.40 m.

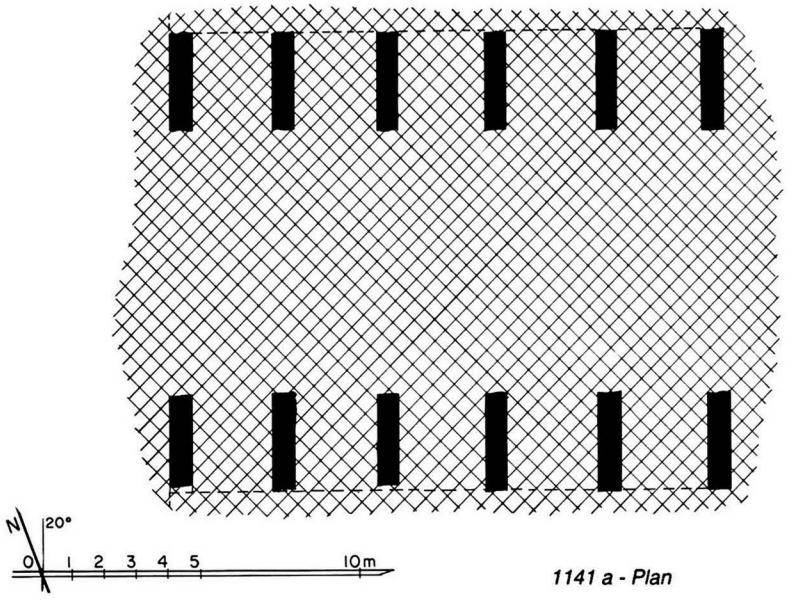
1141 a - Plan

5 present condition
- ruined.
- only base of walls remains, height: 1.90 m.
- ground floor buried under debris.

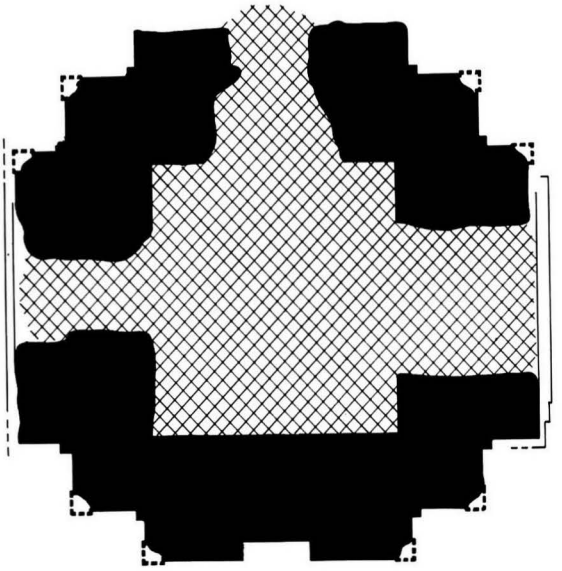
1142 a - Plan

5 present condition
- ruined.
- vaults and upper parts collapsed.
- ground floor buried under debris.

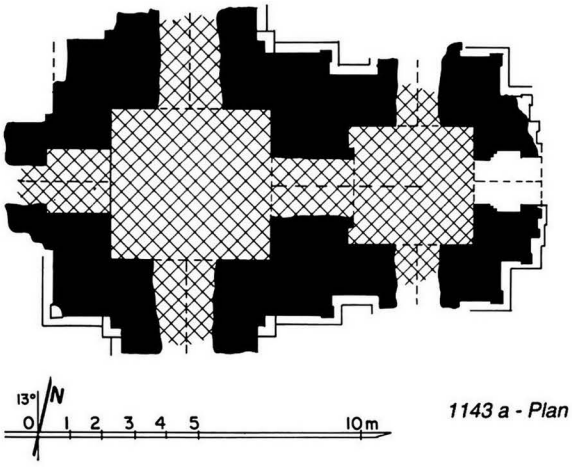
1143 a - Plan

5 present condition
- ruined.
- vaults and upper parts collapsed.
- ground floor buried under debris.

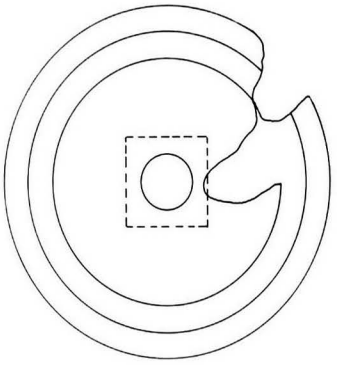
1144 a - Plan

5 present condition
- no maintenance.
- base and terraces disintegrated.
- upper parts badly damaged.

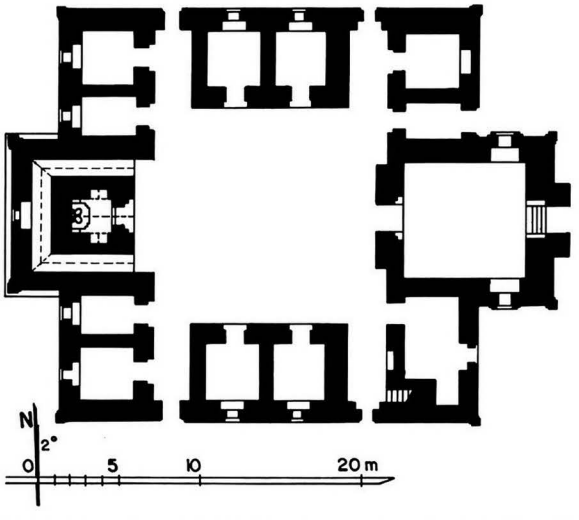
5 present condition
- regularly maintained.
- vault and roof collapsed over cells.
- cleared of debris 1935.
- repaired 1982 and 1993.

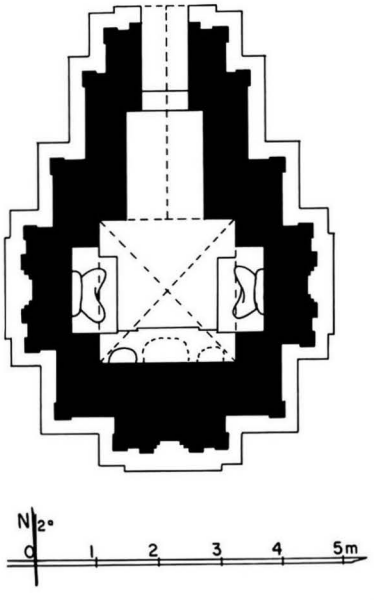
1148 a - Plan

5 present condition
- regularly maintained.
- repaired 1992.

6 images
- 1 seated Buddha and 2 disciples (?), facing north (heavily damaged and headless).
- 2 seated Buddhas (?), facing east and west in lateral niches (damaged and headless).

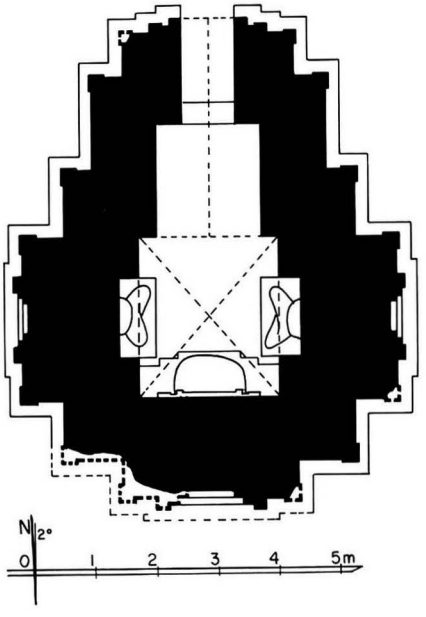
1149 a - Plan

5 present condition
- base disintegrated.
- upper parts badly damaged.

6 images
- 1 seated Buddha, facing north (destroyed).
- 2 seated Buddhas, facing east and west in lateral niches (damaged and headless).

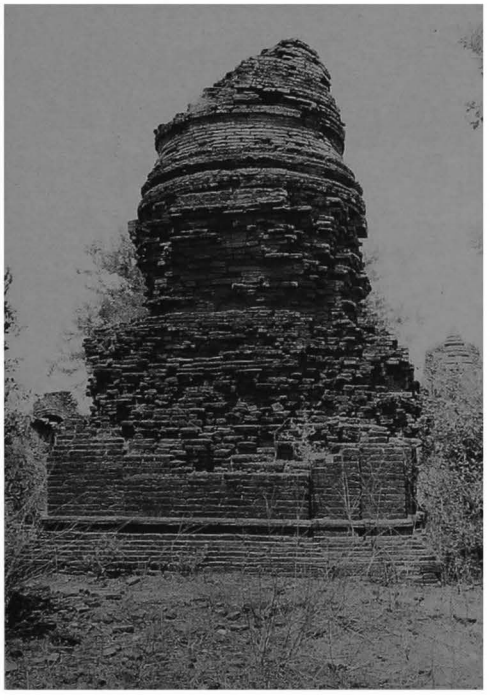
1154 b - East face

5 present condition
- half-ruined and endangered.
- terraces disintegrated.
- upper parts badly damaged.

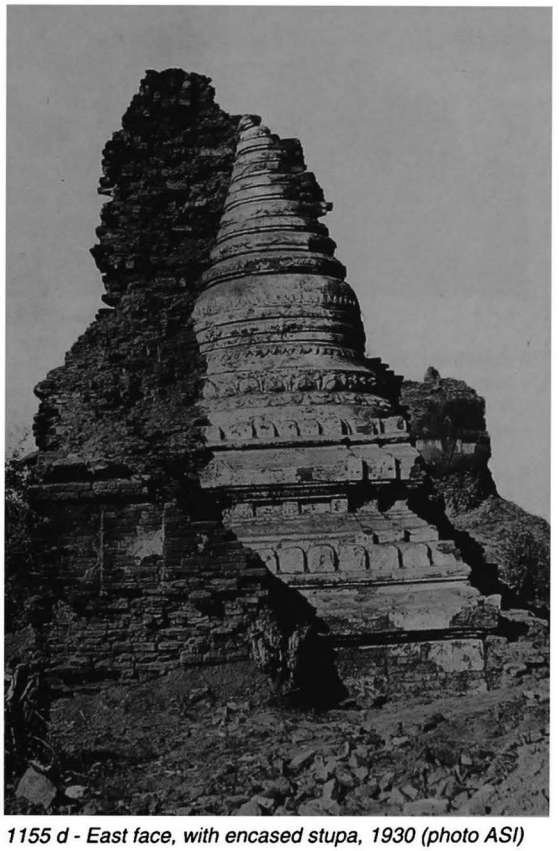
1155 d - East face, with encased stupa, 1930 (photo ASI)

5 present condition
- half-ruined.

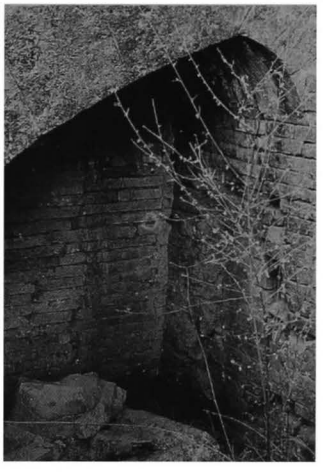
1156 e - Shrine, south niche and image, from north-east

6 images
- 1 seated Buddha, facing east (damaged and headless).
- 1 stone image, seated Buddha facing north, in south niche (damaged and headless).

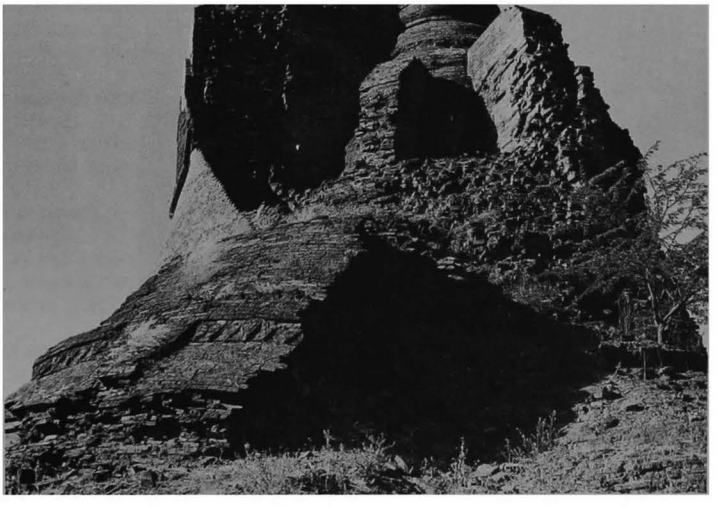
5 present condition
- half-ruined.
- base buried under debris.
- repaired (Arch. Dept.) 1983.

1158 f - Upper parts, detail showing a portion of dome that has collapsed, 1986

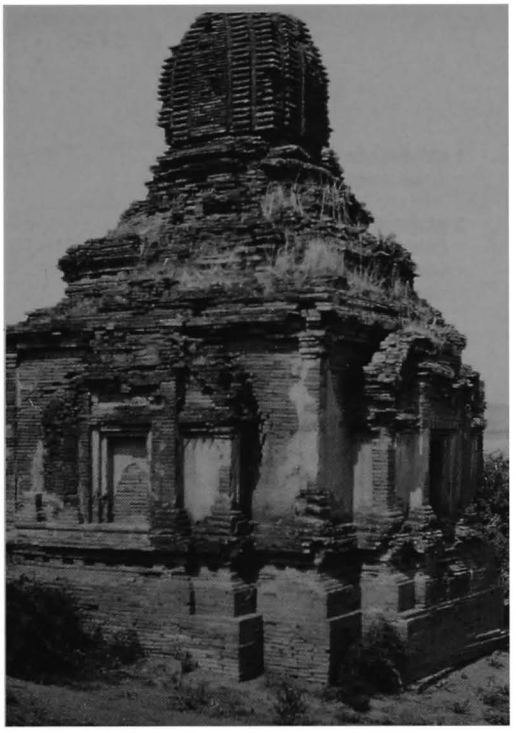
1165 e - From north-east, after repair, 1994

5 present condition
- upper parts badly damaged.
- structure cracked.
- base repaired (Arch. Dept.) 1993.

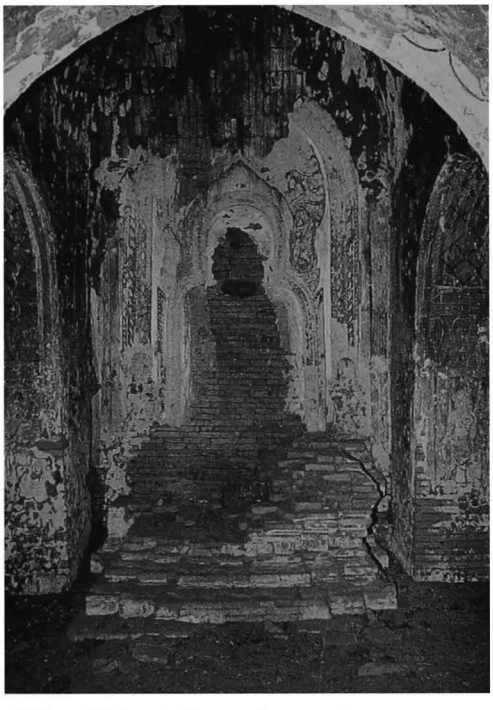
1170 e - Shrine and image, from north

5 present condition
- no regular maintenance.

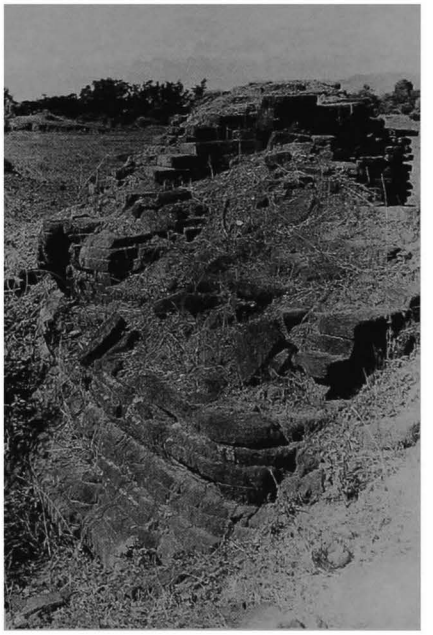
1172 d - Remains of image from north-east

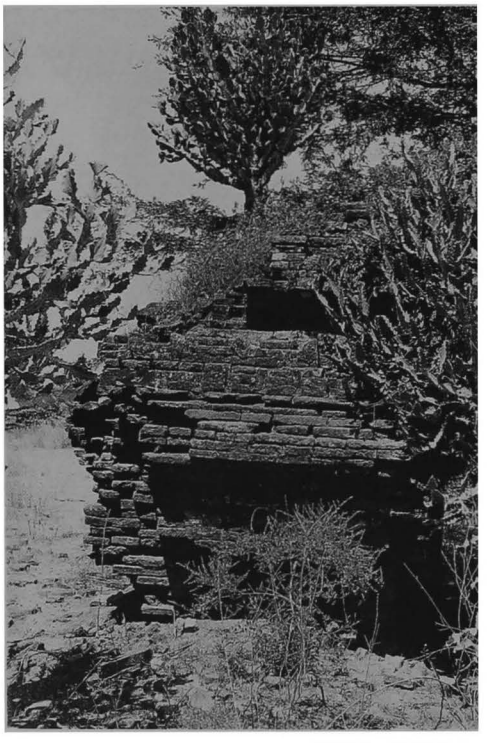
5 present condition
- half-ruined.
- upper parts collapsed.

1181 b - East face

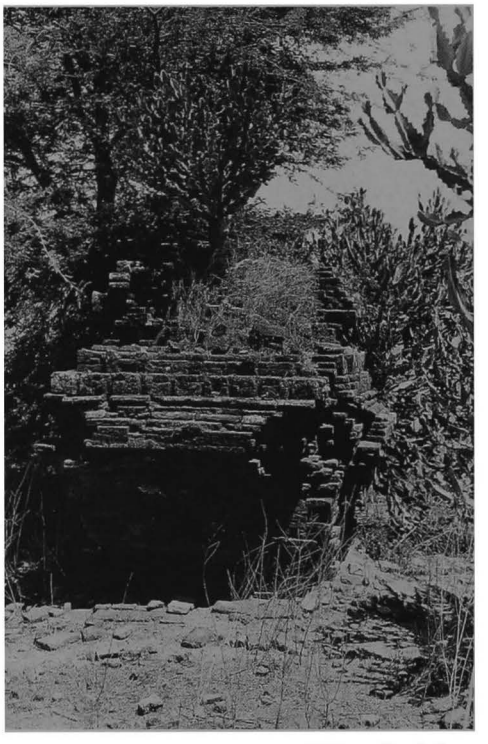
1181 c - South face

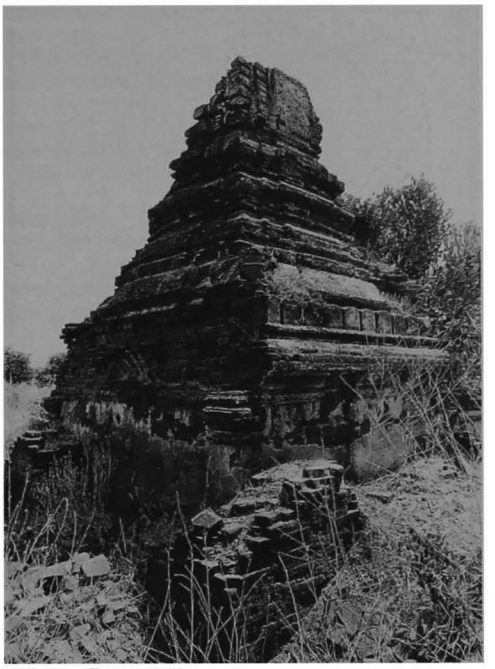
1182 b - From south-west

5 present condition
- no maintenance.
- base buried under debris.
- upper parts damaged.

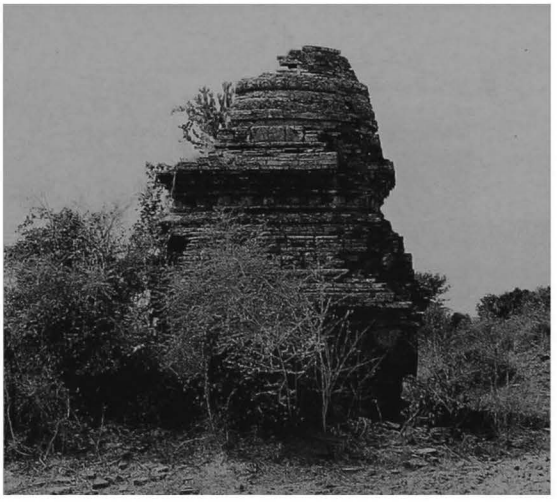
1184 c - From north

5 present condition
- half-ruined.
- base disintegrated.
- upper parts nearly destroyed.

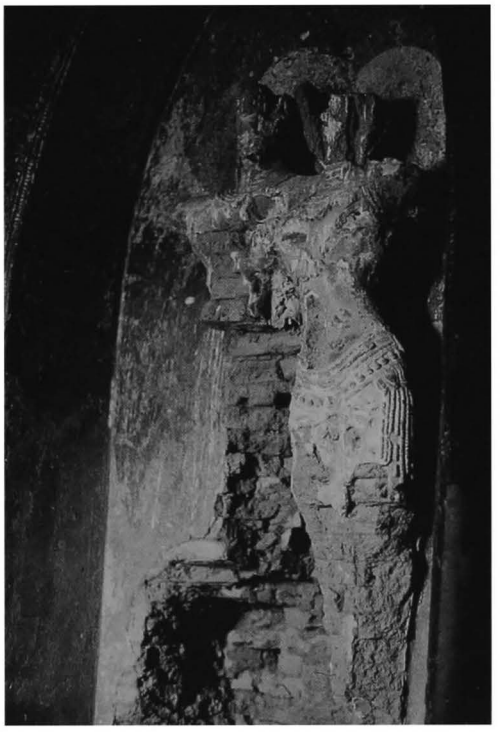
6 images
- 1 seated Buddha, facing east (damaged and headless).
- 1 seated Buddha, facing south (legs only remain).
- 1 reclining Buddha, facing west (disappeared).
- 2 standing figures, facing north
(damaged and headless).

remark
- the twin standing images of north niche are exceptional in Pagan.

1185 f - Core, north niche, standing figures, from north-west

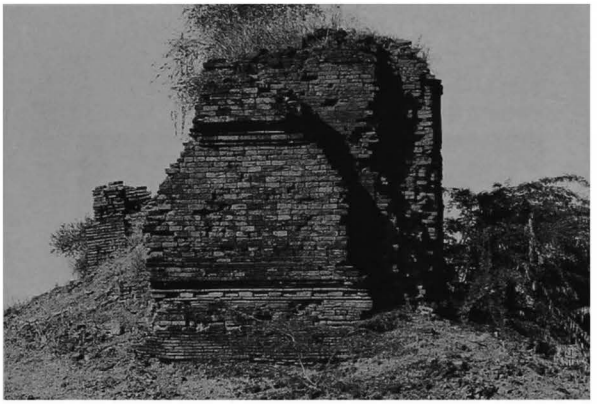
1186 c - West face, from south-west

5 present condition
- half-ruined.
- west part collapsed.
- vaults and upper parts collapsed.
- ground floor buried under debris.

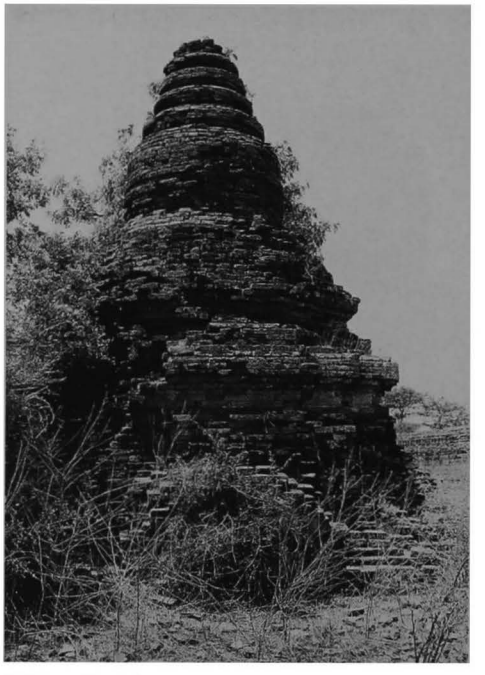
1188 c - North face

5 present condition
- no maintenance.
- base damaged.

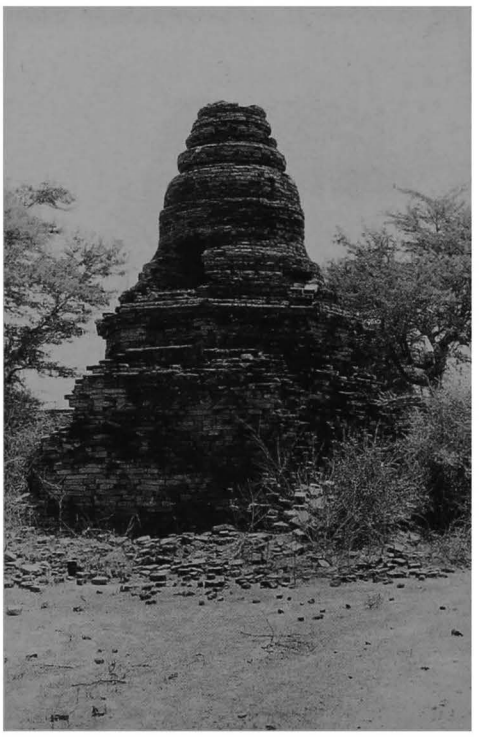
1190 c - From south-west

5 present condition
- no maintenance.
- base and terraces damaged.

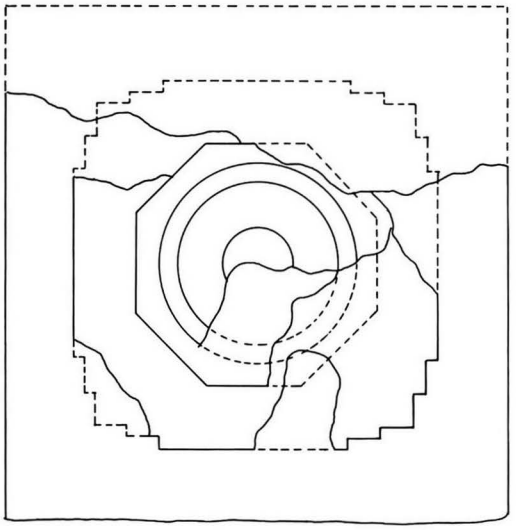
5 present condition
- base and terraces damaged.
- upper parts badly damaged.
- repaired (Arch. Dept.) 1988.

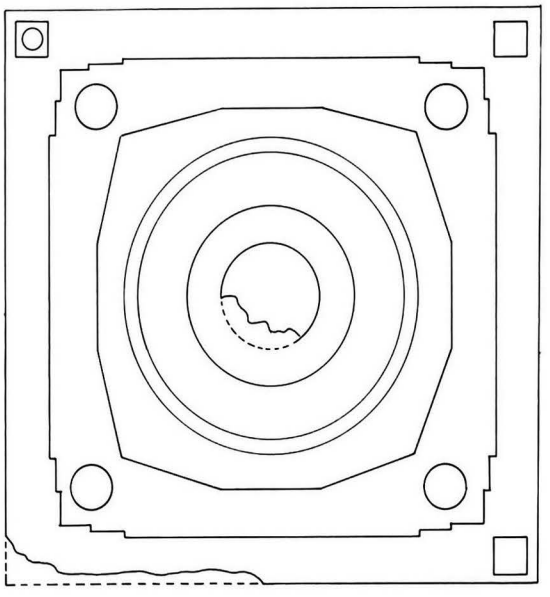
5 present condition
- maintained.
- base and terraces damaged.

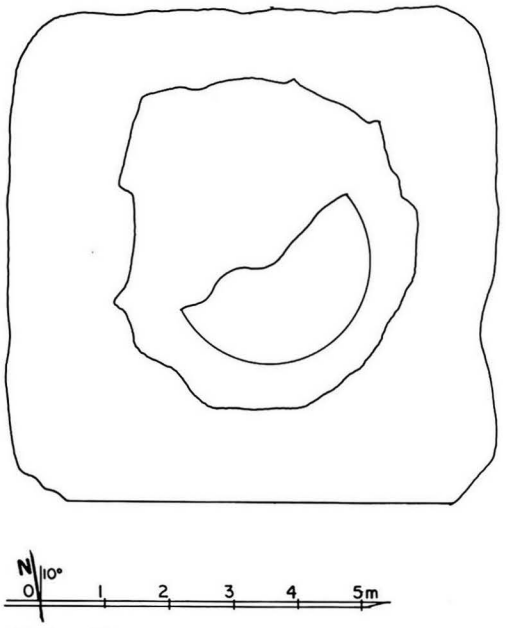
5 present condition
- ruined.
- base and terraces disintegrated.
- upper parts nearly destroyed.
- repaired (Arch. Dept.) 1988.

1196 b - From north-west, 1986, before clearing and repair, together with 1192 in background

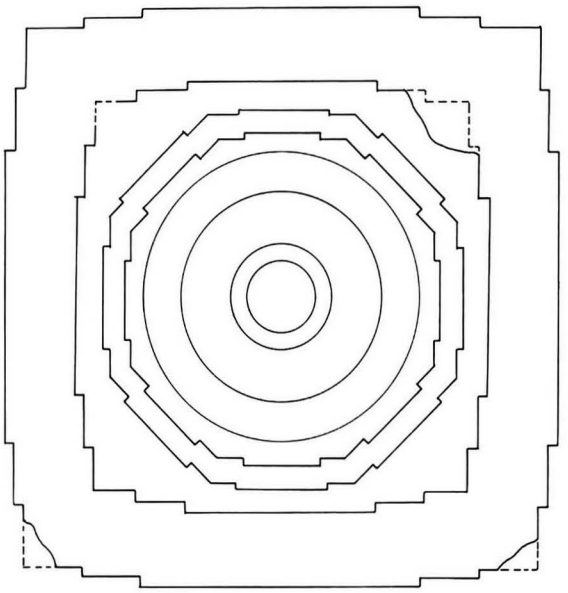
5 present condition
- no maintenance.
- terraces damaged.

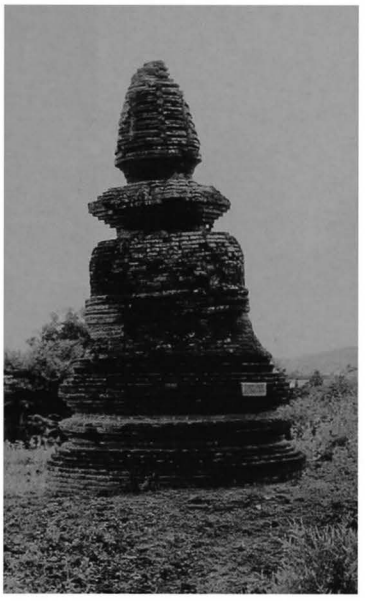
5 present condition
- previously encased (?), cleared 1905.
- upper part leaning eastwards.
- repaired (Arch. Dept.) 1988.

1198 b - From north, before repair, 1986

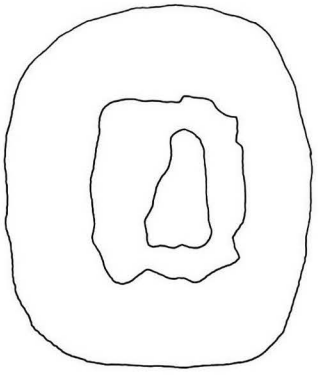
1199 a - Plan

5 present condition
- ruined.
- present height: 2.50 m.

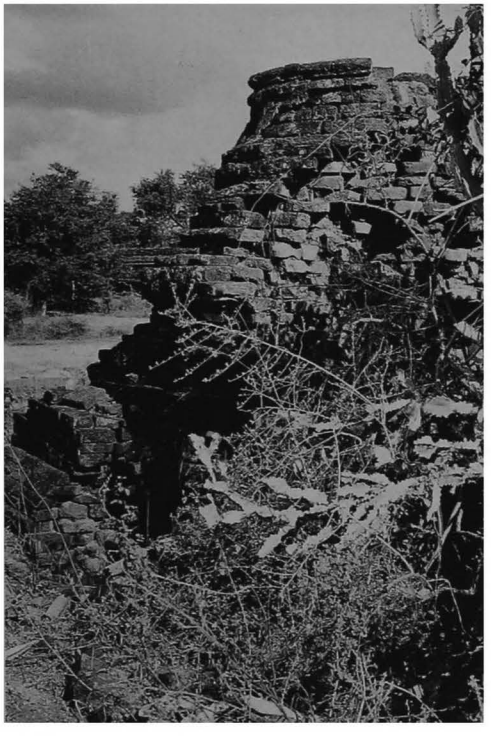
1200 b - From north-west

5 present condition
- half-ruined.
- base and terraces disintegrated.
- upper parts badly damaged.
